MASSACHUSETTS HISTORICAL COMMISSION FORM B - BUILDING

Town Provincetown
Place (neighborhood or village)
Address 12 ALDEN ST
Building ID 124
Parcel No. (PID) 12-1-029-0
Mapbase # 12-1-029
Building Area 748.733
Historic Name
Present Use Residential
Original Use Residential
Date of Construction 1850-1880
Source NR Nomination
Style/Form Greek Revival, Vernacular
Architect/Builder
Exterior Material wood shingle
Foundation obscured
Wall/Trim wood
Roof Side gable
Outbuildings/Secondary Structures

Recorded by Johnette Davies
Organization Kise Straw & Kolodner
Date (month/year) April 2004
Form Status new update

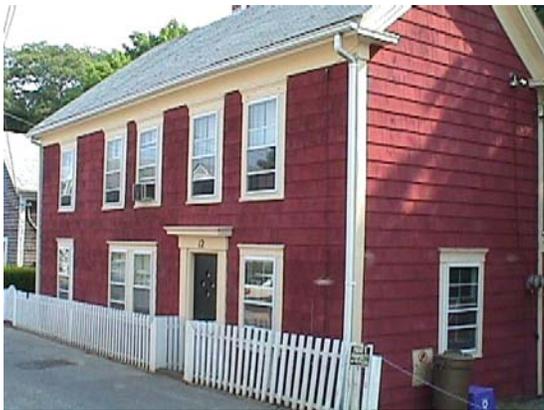
12 Alden Street is a 2-story, 5-bay residence with offset entry. The southern 3-bay section of the side gable roof is taller than the remainder of the main roof to accommodate an additional bay in depth. Brick ridge chimney is located on this taller section, and a second brick chimney is located on the rear slope of the 1-pile (north) section. Partial cornice returns and frieze below eaves. The main entry door is a replacement diamond patterned diamond pane door with shallow flat hood. Windows are 2/2 wood DHS with storms and wood surrounds. A 1-story addition is located at the northwest corner of the building.
