# MASSACHUSETTS HISTORICAL COMMISSION FORM B - BUILDING

**Town** Provincetown  
**Place** (neighborhood or village)  
**Address** 4 NICKERSON ST  
**Building ID** 1220  
**Parcel No. (PID)** 06-2-072-0  
**Mapbase #** 06-2-072  
**Building Area** 1204.979  
**Historic Name**  
**Present Use** Residential  
**Original Use** Residential  
**Date of Construction** 1850-1870  
**Source** NR Nomination  
**Style/Form** Italianate  
**Architect/Builder**  
**Exterior Material** clapboard  
**Foundation** brick  
**Wall/Trim** wood  
**Roof** Front gable  
**Outbuildings/Secondary Structures**  
 1 shed

**Recorded by** Johnette Davies  
**Organization** Kise Straw & Kolodner  
**Date** (month/year) April 2004  
**Form Status**  new  update

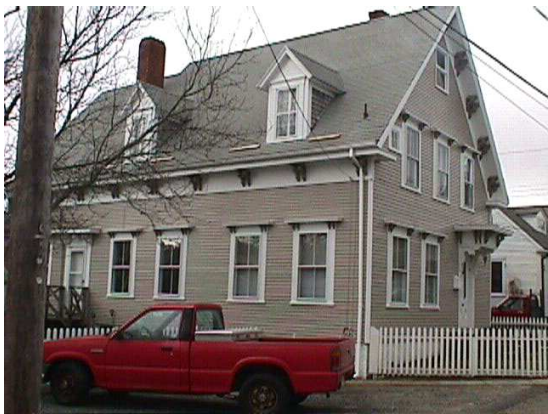
### Photograph

4 Nickerson Street is a 2-story, 3-bay sidehall cottage. The front gable roof has partial returns; brick chimney; 2 gable dormers on south slope and 1 on north slope. Shed roof dormer on north roof slope, rear section. Paired brackets line the eaves. A brick stoop leads to the main entry door, which consists of 2 arched panes and shaped panels; flat hood with paired brackets and pendant end brackets. A secondary entry is located on the south facade with a small hood and paired brackets; wood steps to door. Windows are 2/2 DHS with storms, except 1/1 DHS in gable end; paired 4-light casements in dormers; single-light awning basement windows. Paired brackets present at all window lintels. 1-story entry addition at the rear.
