# MASSACHUSETTS HISTORICAL COMMISSION FORM B - BUILDING

<b>Town</b>	Provincetown
<b>Place</b> <i>(neighborhood or village)</i>	
<b>Address</b>	5 TREMONT ST
<b>Building ID</b>	1450
<b>Parcel No. (PID)</b>	06-4-080-0
<b>Mapbase #</b>	06-4-080
<b>Building Area</b>	1747.478
<b>Historic Name</b>	
<b>Present Use</b>	Commercial - Lodging
<b>Original Use</b>	Residential
<b>Date of Construction</b>	1905
<b>Source</b>	Tax Assessment
<b>Style/Form</b>	Colonial Revival
<b>Architect/Builder</b>	
<b>Exterior Material</b>	Shingle
<b>Foundation</b>	brick
<b>Wall/Trim</b>	wood
<b>Roof</b>	cross hipped
<b>Outbuildings/Secondary Structures</b>

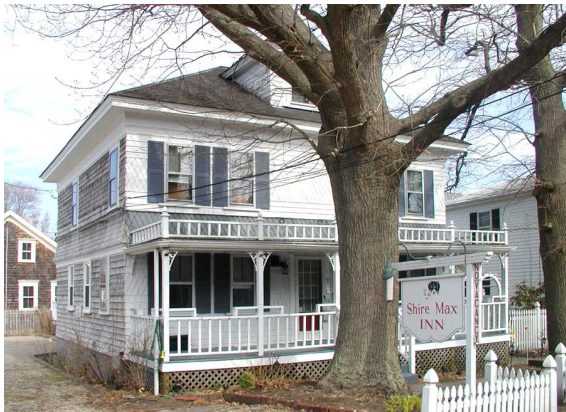
2 1/2-story, 5-bay; asphalt roof shingles; hipped dormer; rear shed dormer; rear interior brick chimney; slight wall flare between 1st and 2nd floors; overhanging eave; bands of diamond shaped wood shingles; main entrance contains multi-pane wood door with modern storm accessing full facade front porch with flat roof, square wood balustrade, decorative brackets, exposed roof rafters, balustrade around roof, lattice work at bottom and reached by centered wood steps; 2/1 wood DHS on front facade with inoperable shutters, 6/6 wood DHS in dormer, 2/1 wood DHS on east side in shed dormer, windows on 1st floor at rear of east side has Greek Revival window surrounds; 2/1 wood DHS, 1/1 vinyl DHS on west side; steps and deck on 2nd floor rear entrance on east side; open 1st floor deck extends along rear of west side.
