MASSACHUSETTS HISTORICAL COMMISSION FORM B - BUILDING

Town Provincetown
Place (neighborhood or village)
Address 56 BRADFORD ST
Building ID 1489
Parcel No. (PID) 07-2-117-0
Mapbase # 07-2-117
Building Area 1303.634
Historic Name
Present Use Residential
Original Use Residential
Date of Construction 1951
Source Tax assessment
Style/Form Colonial Revival
Architect/Builder
Exterior Material clapboard
Foundation concrete block
Wall/Trim wood
Roof Front gable
Outbuildings/Secondary Structures
 1 former garage.

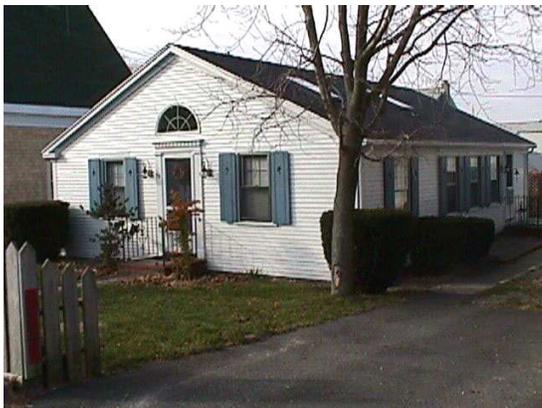
Photograph

56 Bradford Street is a 1-story, 3-bay gable front dwelling with a rear ell. The central entrance contains a panel door surrounded by pilasters and a denticulated entablature. A fanlight with snap-in muntins is located above the door surround. There is a small brick stoop at the front entry, with metal railings. Windows are 6/1 replacement DHS, and they are flanked by inoperable shutters. A secondary entry is located at the end of the side (northeast) elevation. There are skylights in the roof slope. The west façade contains 6/1 DHS with operable shutters. The east façade contains wood 6/1 DHS and secondary entry.
