MASSACHUSETTS HISTORICAL COMMISSION FORM B - BUILDING

Town Provincetown
Place (neighborhood or village)
Address 77 BRADFORD ST
Building ID 1778
Parcel No. (PID) 07-4-004-0
Mapbase # 07-4-004
Building Area 1086.674
Historic Name
Present Use Residential
Original Use Residential
Date of Construction 1850
Source Henry F. Walling Map, 1858
Style/Form Greek Revival
Architect/Builder
Exterior Material clapboard
Foundation obscured
Wall/Trim wood
Roof Side gable
Outbuildings/Secondary Structures

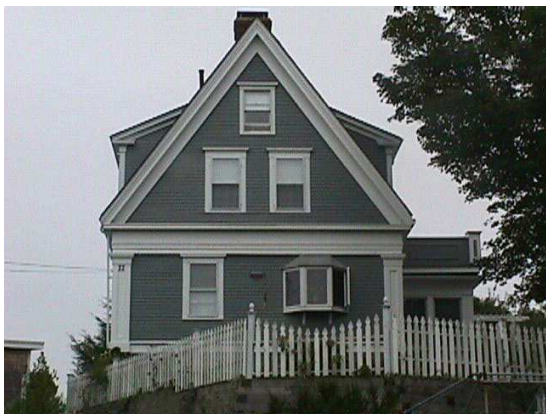
Photograph

77 Bradford Street is a 2-story, 3-bay, Greek Revival-style sidehall dwelling; the roof is side gable, it has a full return and entablature, a brick chimney is located at the roof ridge, and shed dormers, with slight returns, have been added to the front and rear roof slopes. ; the exterior is clad in clapboard, the facades are framed by pilasters, coved cornice at the gable ends, and the foundation is obscured; the fenestration includes 6/6 vinyl DHS replacements with wood trim and entablatures, a canted bay window has been added to the gable end facing north; the entablature of windows on the 1st story meet the frieze board; An enclosed porch has been added to the rear, and a deck is located on top of the porch roof.
