# MASSACHUSETTS HISTORICAL COMMISSION FORM B - BUILDING

**Town** Provincetown  
**Place** (neighborhood or village)  
**Address** 22 ALDEN ST  
**Building ID** 610  
**Parcel No. (PID)** 12-1-033-0  
**Mapbase #** 12-1-033  
**Building Area** 1074.873  
**Historic Name**  
**Present Use** Residential - Multi-unit  
**Original Use** Residential  
**Date of Construction** 1850-1870  
**Source** NR Nomination  
**Style/Form** Greek Revival  
**Architect/Builder**  
**Exterior Material** wood shingle  
**Foundation** stuccoed  
**Wall/Trim** wood  
**Roof** Front gable  
**Outbuildings/Secondary Structures**

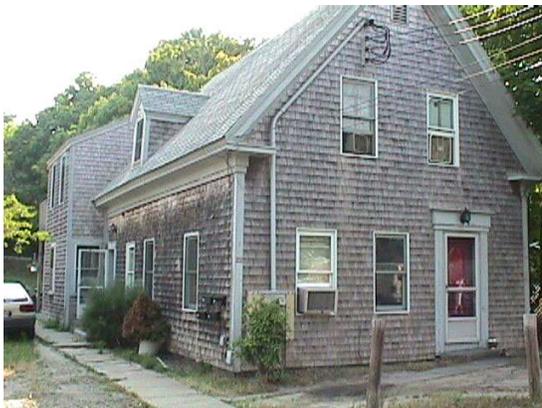
### Photograph

Multi-unit conversion; 2-story addition; window sash & siding (1988)

**Condition** Fair  
**Moved**  no  yes **Date**  
**Acreage** 0.138  
**Setting**

22 Alden Street is a 2-story, 3-bay sidehall dwelling with a 2-story rear addition and wood shingle cladding. The front-gable roof has asphalt shingle cladding, partial returns, shed dormer on north slope, and gable dormer on south slope. Minimal corner pilasters; frieze below eaves. The main entry contains an oval pane and panel door with storm; surround with entablature and pilasters. Fenestration includes replacement wood 1/1 DHS with storms. A secondary entry is located near the rear of the south facade. The 2-story rear addition contains 1/1 and 2/1 DHS windows. Exterior steps to a second-story entry at the rear of the addition.
