MASSACHUSETTS HISTORICAL COMMISSION FORM B - BUILDING

Town Provincetown
Place (neighborhood or village)
Address 5 ALDEN ST
Building ID 1395
Parcel No. (PID) 12-1-045-0
Mapbase # 12-1-045
Building Area 806.412
Historic Name
Present Use Residential
Original Use Residential
Date of Construction 1830-1850
Source NR Nomination
Style/Form Astylistic
Architect/Builder
Exterior Material vinyl
Foundation brick
Wall/Trim vinyl
Roof cross gable
Outbuildings/Secondary Structures
 1-story shed/workshop

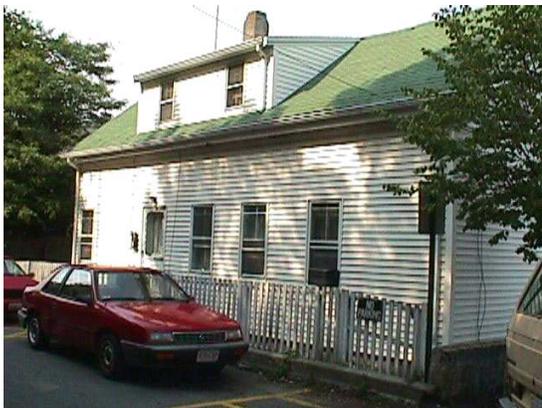
Photograph

This is a 1 1/2-story, 5-bay building with asphalt shingle-clad side gable roof. The roof has partial cornice returns; shed dormer on front (west) roof slope with 6/6 DHS wood windows; rear (east) shed dormer with 1/1 DHS vinyl; stuccoed (brick) interior chimney at peak. Main entry is a pane and panel wood door with modern aluminum storm. Fenestration outside of dormers is generally 2/2 wood DHS. A 1-story gable roof ell addition with concrete block foundation is located at the rear. An exterior stair leads to a 2nd floor entrance at the rear.
