MASSACHUSETTS HISTORICAL COMMISSION FORM B - BUILDING

Town Provincetown
Place (neighborhood or village)
Address 160 BRADFORD ST
Building ID 344
Parcel No. (PID) 12-3-058-0
Mapbase # 12-3-058
Building Area 1697.368
Historic Name
Present Use Commercial - Lodging
Original Use Residential
Date of Construction 1860
Source Plaque on building
Style/Form Stick
Architect/Builder
Exterior Material abestos shingle
Foundation brick
Wall/Trim wood
Roof Gambrel
Outbuildings/Secondary Structures

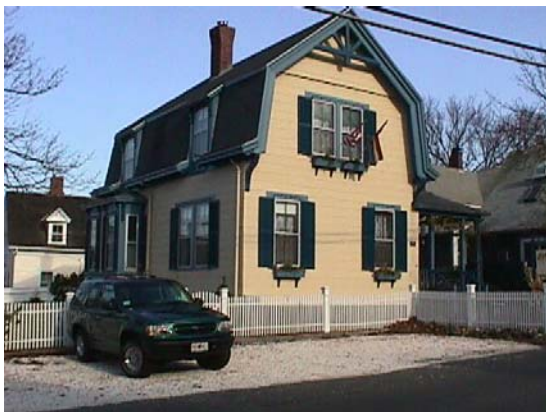
Photograph

Currently "Seasons: An Inn for All"; 160 Bradford Street is a 2-story, 2-bay building. The gambrel roof has flared eaves and a decorative truss in the gable end. This truss and a squared bay window on the west façade indicate the Stick style, while the verticality of the building is reminiscent of the Gothic Revival. The squared bay window faces Pearl Street. The remainder of the windows are single or paired 2/2 DHS with inoperable shutters. 2 shallow, shed-roofed wall dormers break the roof cornice on the west façade. Brackets are located here and at the bay window eaves.. A 1-story open porch with chamfered posts is located on the eastern façade. A brick interior chimney is located on the roof slope, near the ridge. A 1 story mansard roof section with a separate entry is located to the rear. This also has 2/2 DHS windows. There are exposed rafter ends below the eaves, and rosettes where the wall dormer break the gable roof flares.
