MASSACHUSETTS HISTORICAL COMMISSION FORM B - BUILDING

Town Provincetown
Place (neighborhood or village)
Address 12 ATLANTIC AVE
Building ID 125
Parcel No. (PID) 07-2-010-0
Mapbase # 07-2-010
Building Area 1113.695
Historic Name
Present Use unknown
Original Use Residential
Date of Construction 1850
Source Tax assessment
Style/Form Italianate
Architect/Builder
Exterior Material wood shingle
Foundation brick
Wall/Trim wood
Roof front gable-asphalt
Outbuildings/Secondary Structures

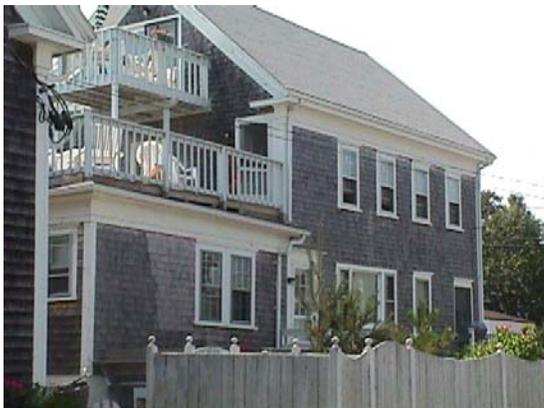
12 Atlantic Avenue is a 2-story, 3-bay building with a rear ell; the building faces Bradford Street. The front-gable roof is clad in asphalt shingles, has partial returns; skylights; rear exterior brick chimney (south). Corner pilasters present. The main entrance is centered on the Bradford Street façade. It contains a new wood pane and panel door with art glass, and is shaded by a flat hood supported by brackets. A secondary entrance is located on the east façade, facing Atlantic Avenue. Fenestration includes 6/6 replacement wood and vinyl DHS; 1/1 vinyl DHS; 8/8 vinyl DHS on the front facade next to the door; bay window on the front facade with modern vinyl picture window and DHS flanking; wood window surrounds. A 1-story rear ell is located at the south gable end. This section has a roof deck and access to a 3rd floor entrance and deck. Modern deck on front.
