MASSACHUSETTS HISTORICAL COMMISSION FORM B - BUILDING

Town Provincetown
Place (neighborhood or village)
Address 3 WINTHROP PL
Building ID 950
Parcel No. (PID) 07-2-133-0
Mapbase # 07-2-133
Building Area 1430.61
Historic Name
Present Use Commercial - Lodging
Original Use Residential
Date of Construction 1852
Source Tax assessment
Style/Form Greek Revival
Architect/Builder
Exterior Material shingles and clapboard
Foundation brick
Wall/Trim wood
Roof cross gable, asphalt
Outbuildings/Secondary Structures

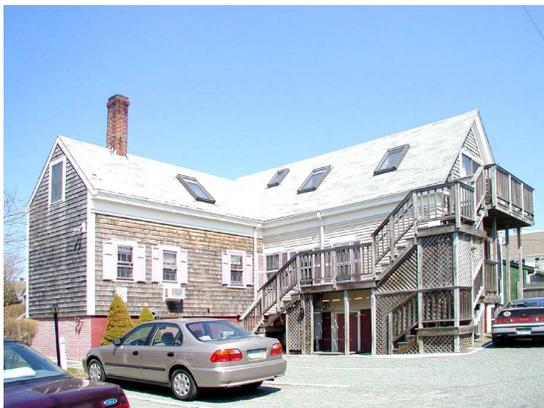
Photograph

3 Winthrop Place is a 1-1/2-story, 3-bay building with side ell; cross-gable roof is sheathed in asphalt shingles; interior brick ridge chimney; skylights; fenestration includes 6/6 DHS wood throughout with operable shutters on front facade and inoperable on other facades, 1/1 wood DHS replacement in basement on front facade; original main entrance is accessed by a pane-and-panel wood door on left side of front (south gable end); partial returns and corner pilasters; 2nd-floor sliding glass doors is accessed by exterior steps and balcony; two basement access doors require step down from grade; north side has 1-story flat-roof addition with poured concrete foundation, Chicago-style window with flanking 4/4 wood DHS, and pane-and-panel door accessed on west side by wood steps and deck; rooftop deck.
