# MASSACHUSETTS HISTORICAL COMMISSION FORM B - BUILDING

**Town** Provincetown  
**Place** (neighborhood or village)  
**Address** 3 STANDISH ST  
**Building ID** 945  
**Parcel No. (PID)** 12-1-021-0  
**Mapbase #** 12-1-021  
**Building Area** 1761.351  
**Historic Name**  
**Present Use** Residential  
**Original Use** Residential - Single-unit  
**Date of Construction** 1870-1880  
**Source** NR Nomination  
**Style/Form** Greek Revival  
**Architect/Builder**  
**Exterior Material** wood shingle  
**Foundation** brick  
**Wall/Trim** wood  
**Roof** cross gable  
**Outbuildings/Secondary Structures**

**Recorded by** Vanessa Zeoli  
**Organization** Kise Straw & Kolodner  
**Date** (month/year) April 2004  
**Form Status**  new  update

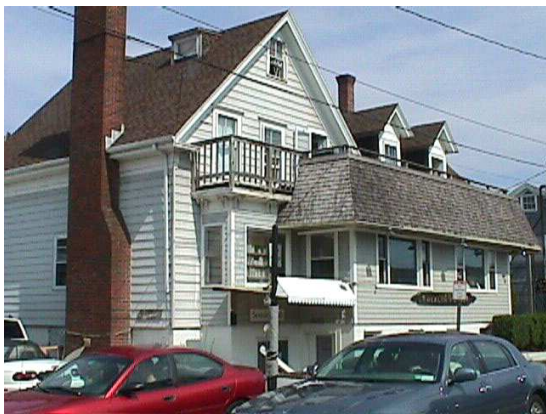
2-story, 3-bay sidehall and 3-4 bay side ell; roof is clad in asphalt shingles; exterior north end brick chimney; partial cornice returns, frieze board; exterior is clad in wood shingles and aluminum siding; primary entrance is located in enclosed 1-story porch addition on front facade containing concrete block foundation, contemporary mansard roof covered in wood shingle, rooftop deck; porch accessed on south side by concrete and brick steps and metal balustrade; fenestration on sidehall section includes 2/1 DHS wood with wood surround, square bay on front of sidehall with flat roof, paired brackets under eave, single-pane fixed picture window and rooftop deck, 2 Chicago-style windows facing street, single-light awnings at basement, small shed dormers on north slope of sidehall with single-pane awning; fenestration on side ell contains a gable dormer with 2/1 wood DHS window; exterior stair to 2nd floor entrance; gable wall dormer on side ell converted to an entrance with a wood panel door and wrought iron gate to deck
